**Waterfront Facilities  
Inspection & Assessment  
at  
Port of Astoria – Pier 1**

**Astoria, Oregon  
June 2026**

**Appledore Project No. 5394**

## Executive Summary

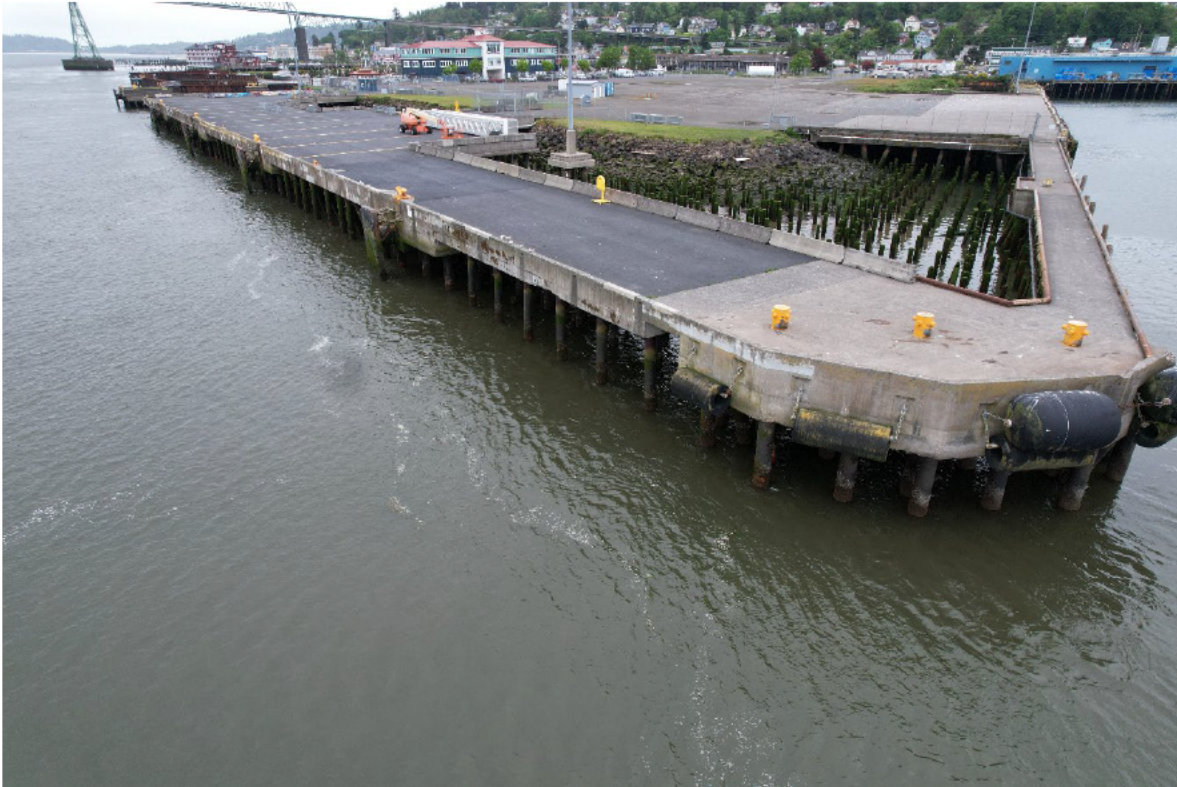
*Overall view of Pier 1, looking east.*

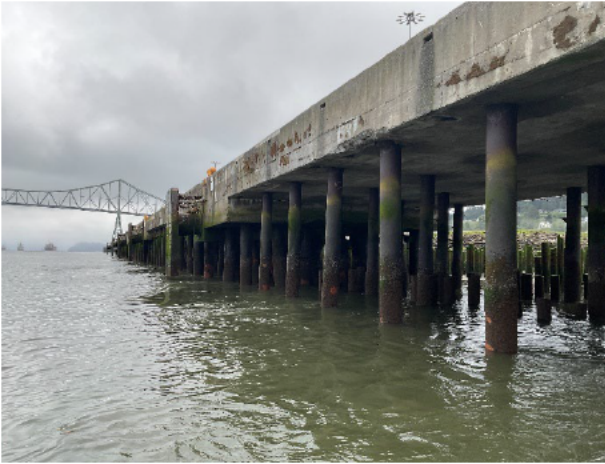
Photo 1: Looking east from Bent 7.

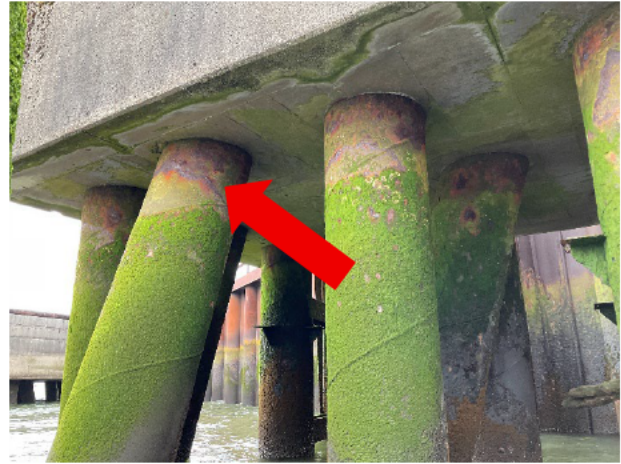
Photo 2: Inshore mooring dolphin, note splash zone corrosion of piles.

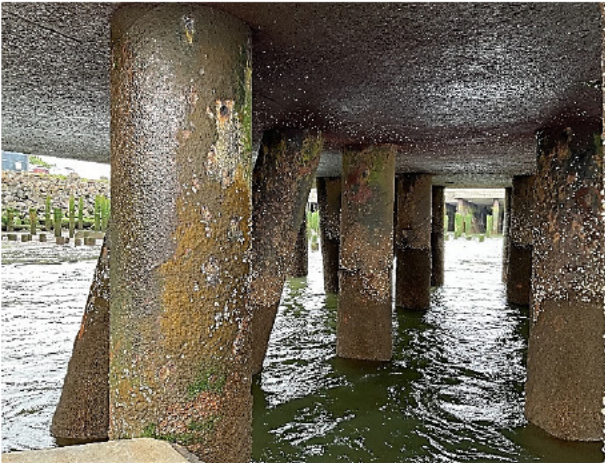
Photo 3: Piles at the breasting dolphin.

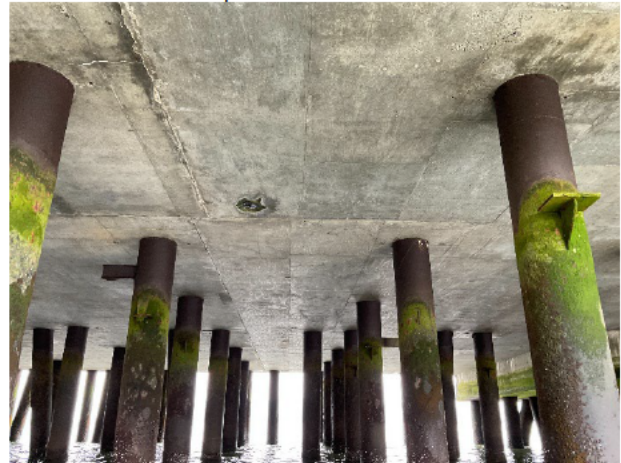
Photo 4: Typical underdeck at Bent 34.

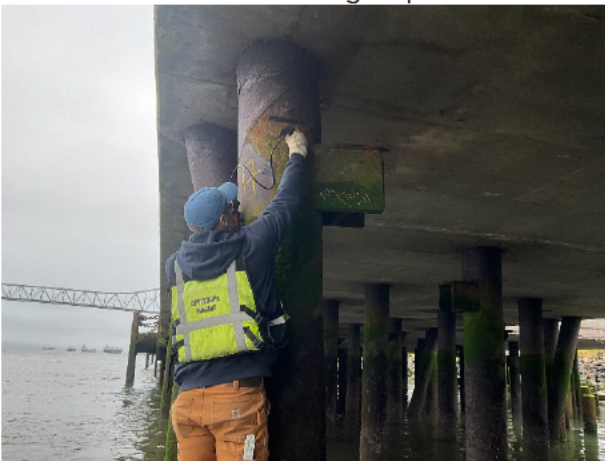
Photo 5: Engineer taking thickness reading at Pile 17:A.

| Asset | Location | | Elevation | UT Reading | | Voltage Potential | Comments |
|---|---|---|---|---|---|---|---|
| Pile | 17 | A | SZ | 0.250 | | | |

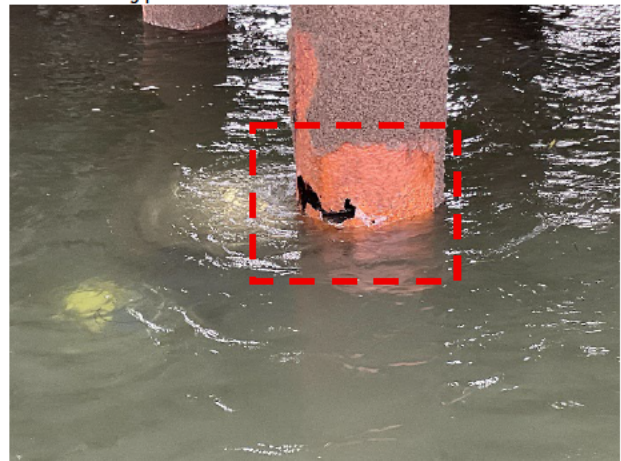
Photo 6: Severe corrosion at low water, Pile 52:B.

| Asset Type | Location | | Defect Type | P<br>(ft) | Defect Size | | Area or<br>Loss<br>(sf or %) | Comments |
|---|---|---|---|---|---|---|---|---|
| Pile | 52 | B | Corrosion Hole | 10 | 0.5 | 0.5 | 100% | |

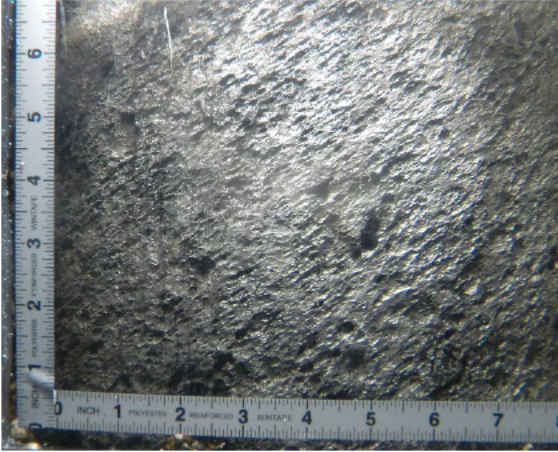
Photo 7: Typical underwater Level II, marine growth and corrosion scale removal, note heavy corrosion and pitting.

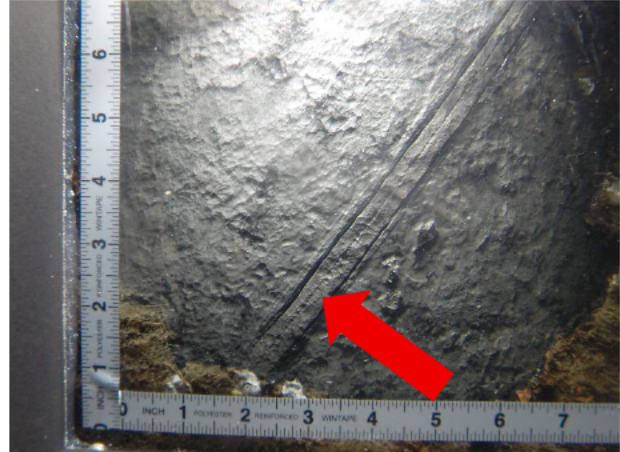
Photo 8: Partial deterioration of the spiral weld at pile 61:D.

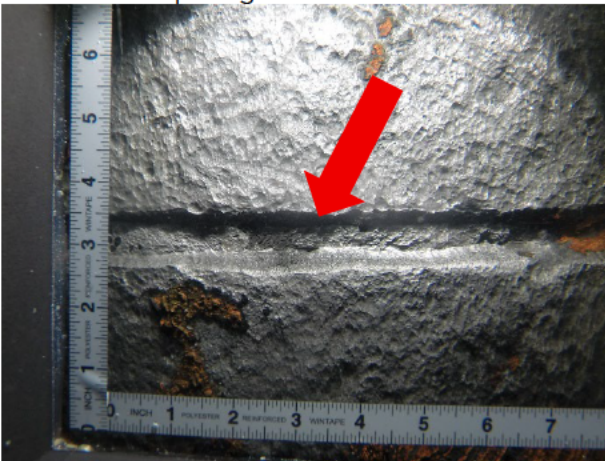
Photo 9: Corrosion of the horizontal weld splice at Pile 62:A.

| Asset Type | Location | | Defect Type | P<br>(ft) | Defect Size | | Area or<br>Loss<br>(sf or %) | Comments |
|---|---|---|---|---|---|---|---|---|
| Pile | 62 | A | Horiz Pile Splice Weld | 20 | | | 50% | |

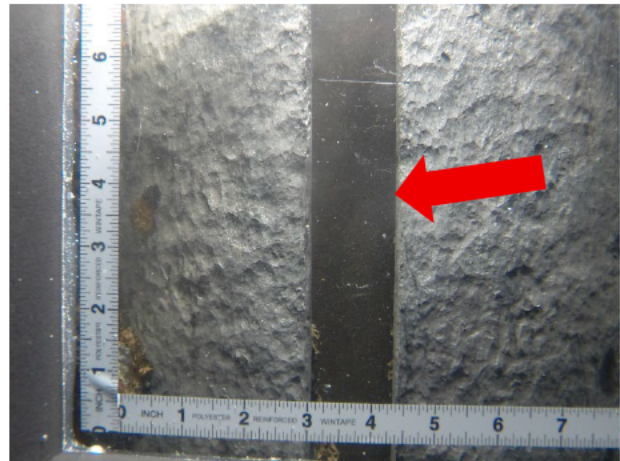
Photo 10: Severe failure of vertical weld seam at Pile 52:B.

| Asset Type | Location | | Defect Type | P<br>(ft) | Defect Size | | Area or<br>Loss<br>(sf or %) | Comments |
|---|---|---|---|---|---|---|---|---|
| Pile | 52 | B | Split Weld/Corrosion Hole | | | | 100% | |

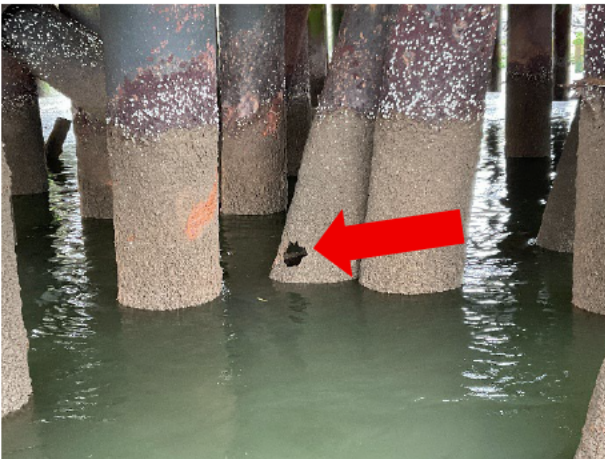
Photo 11: Severe corrosion on Pile 50:B.5, at low water.

| Asset Type | Location | | Defect Type | P<br>(ft) | Defect Size | | Area or<br>Loss<br>(sf or %) | Comments |
|---|---|---|---|---|---|---|---|---|
| Batter Pile | 50 | B.5' | Corrosion Hole | 10 | 1 | 3 | 100% | |
