**Waterfront Facilities  
Inspection & Assessment  
at  
Port of Astoria – Pier 1**

**Astoria, Oregon  
June 2026**

**Appledore Project No. 5394**

## Executive Summary

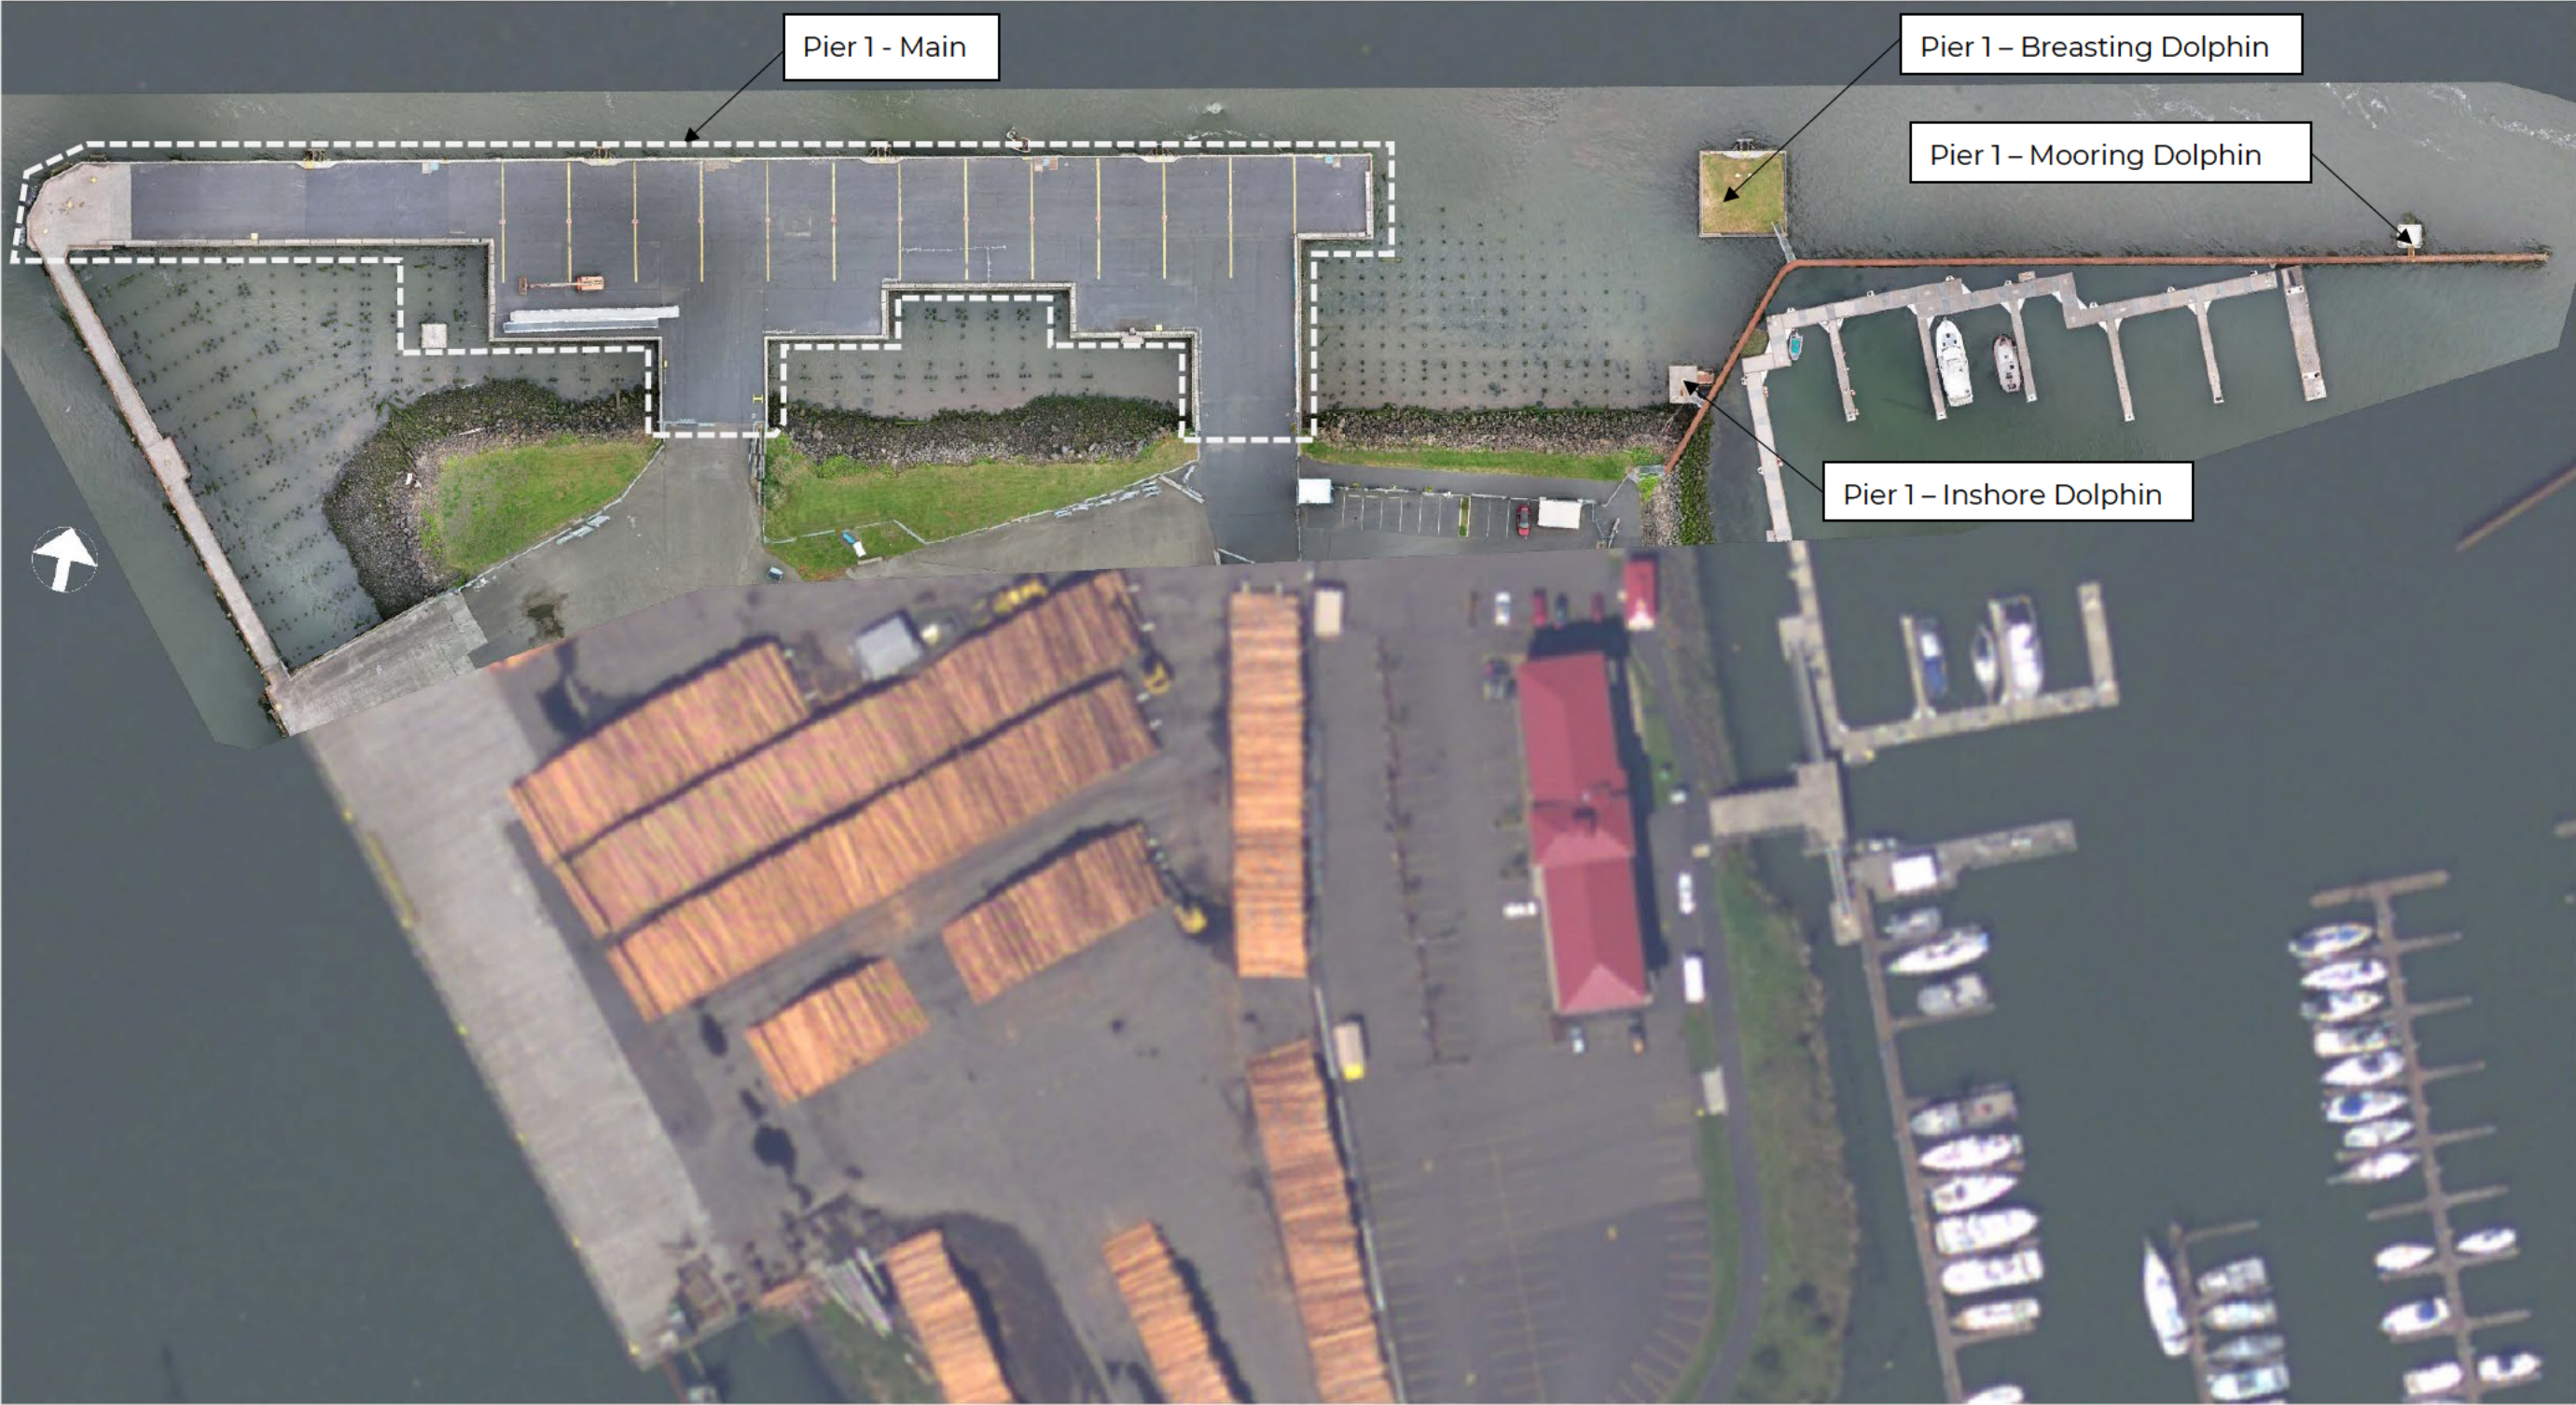
Figure 2-1 Pier 1 - Overall Plan

PIER 1 OVERALL PLAN  
NOT TO SCALE

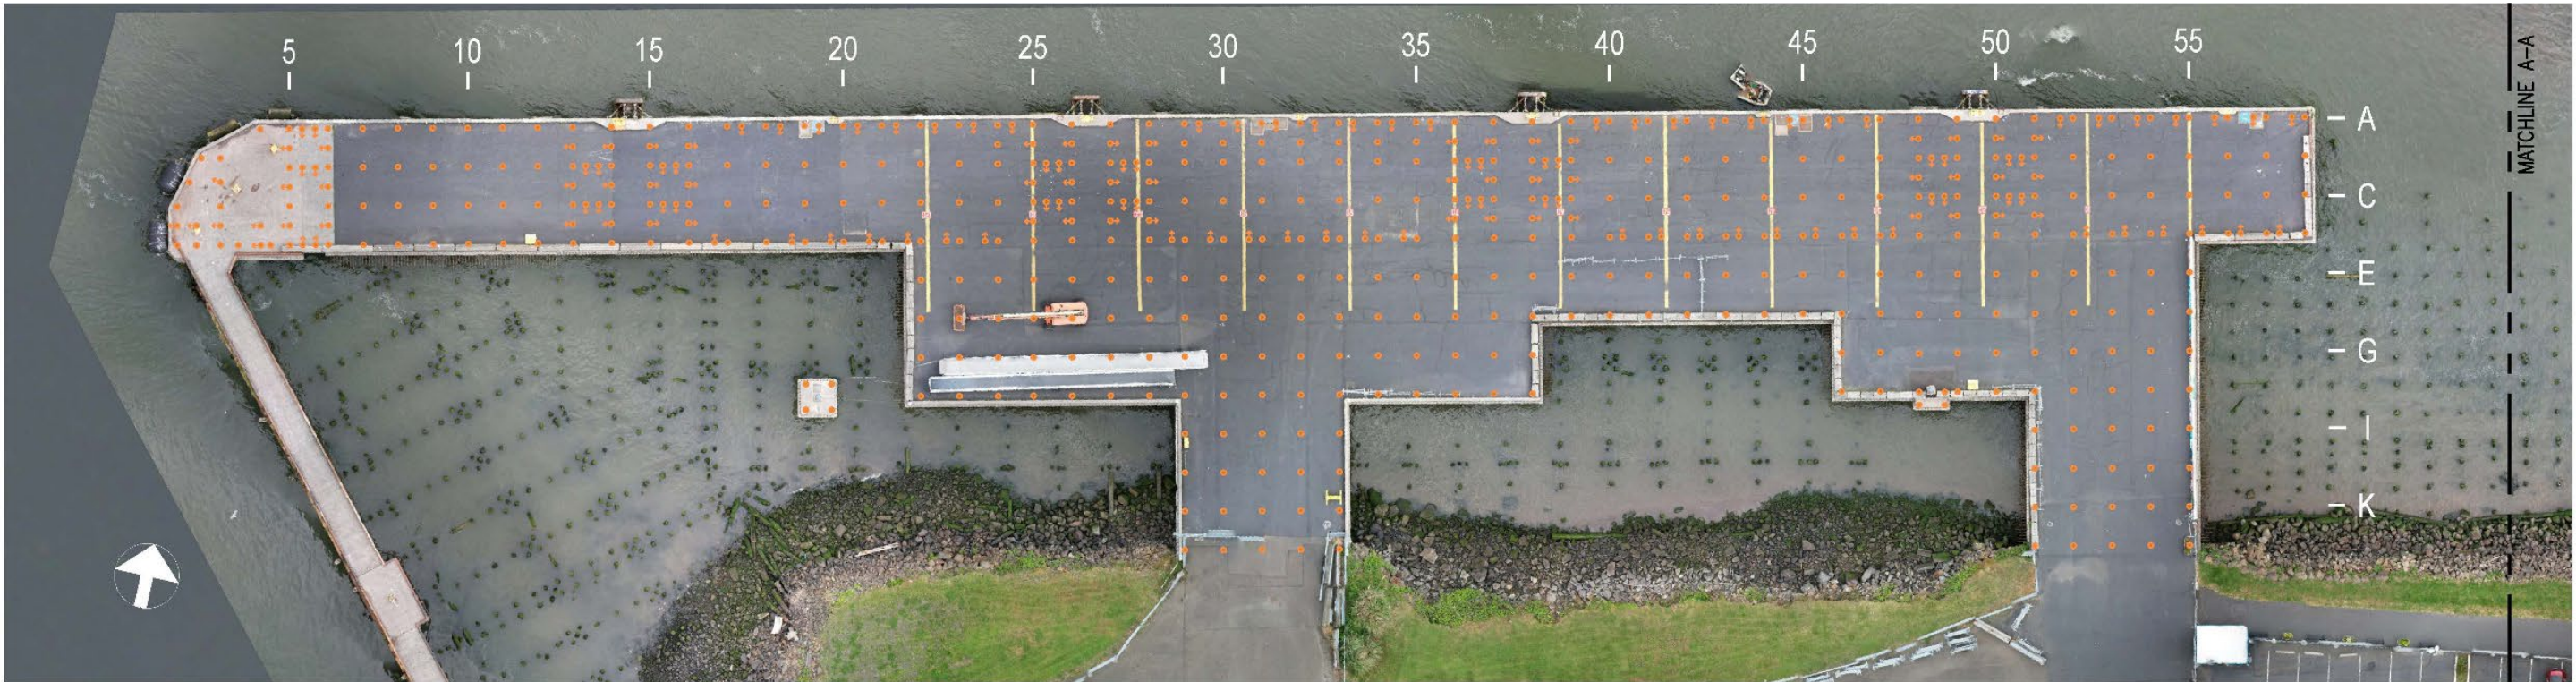
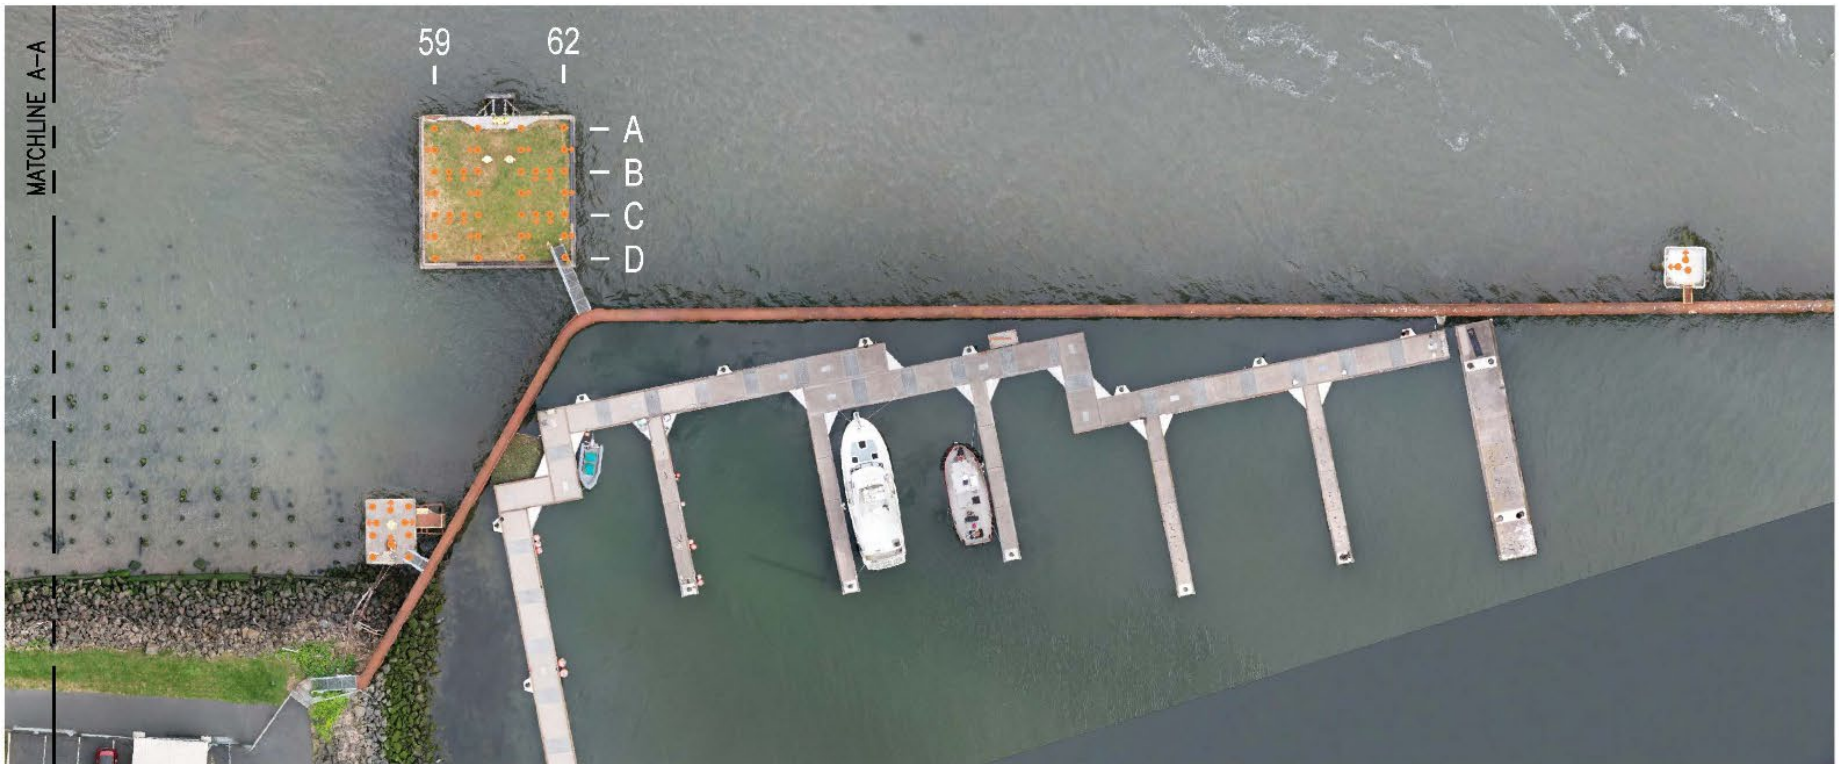
Figure 2-2 Pier 1 – Pile Plan

| Inspection Area | Element | Condition Assessment Rating | Description |
|---|---|---|---|
| Substructure | Steel Piles | Poor | <p>The steel pipe piles are in overall Poor condition due to corrosion loss, opening of the vertical weld seams, and discrete piles with large holes in the low-water zone.</p> <p>The Level I visual inspection on 100% of the piles (without marine growth removal) identified six (6) piles with large corrosion holes at low water, thirty-four (34) piles with split vertical welds, and four (4) piles where the vertical weld is partially deteriorated.</p> <p>For 10% of the piles, Level II close inspections were completed at three bands (Low Water, Mid-Water, and Mudline) after the removal of marine growth. At these locations, Level III ultrasonic thickness measurements of the remaining steel were completed. The Level III measurements identified that 28% of the sample had a 30% section loss of steel thickness, and 69% had a 20% loss.</p> |

PIER 1 PILE PLAN  
NOT TO SCALE

| Condition Assessment Rating | Poor |
|---|---|
| Recommended Considerations and/or Follow-on Action | <ol style="list-style-type: none"> <li>1. Complete a repair design inspection to collect detailed repair requirements on all piles.</li> <li>2. After the design-level inspection, develop design and repair contract drawings to repair structurally deficient piles.</li> </ol> |
